- ITI Wireless Transmitters
- 2000 Series Control Panels
- 6000 Series Control Panels

1.0 Issue

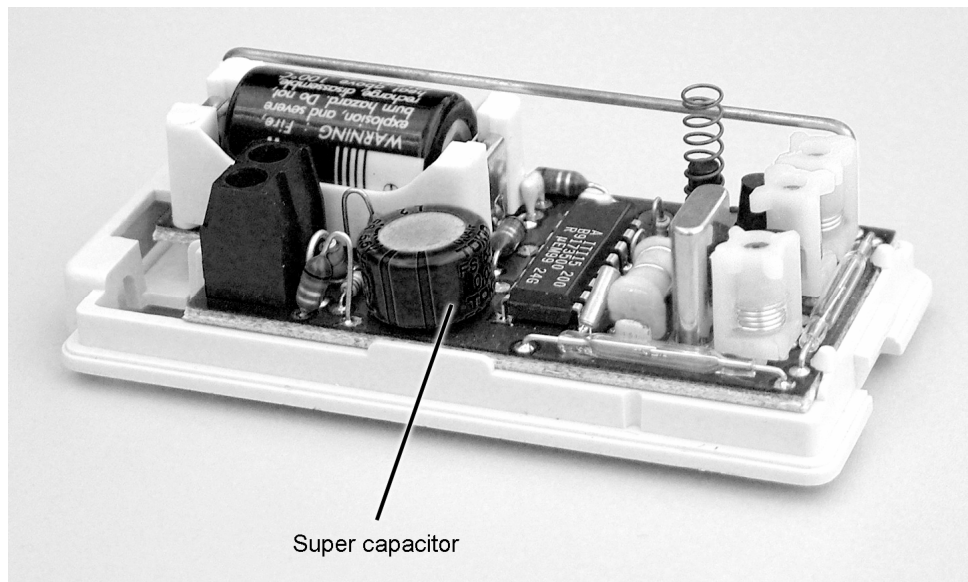
ITI transmitters purchased between February 2004 and June 2005 might send low battery signals to the control panel prematurely. Replacing the batteries fixes the problem for 60 days or less. Only ITI transmitters with a gray super capacitor on the printed circuit board might exhibit this behavior.

Replace all ITI wireless transmitters that exhibit this behavior. For information on what model transmitters are affected, and how to receive a replacement transmitter, refer to the GE Security *Wireless Devices with Gray "Super-Capacitor" Customer Note*, dated November 16, 2006. You can download this document from the GE Security web site at: <http://www.gesecurity.com/GESecurity/images/DWS%20customer%20notice.pdf>.
