# Technical Bulletin

## RPS-control panel USB connection on Windows 10

**August 9, 2016**

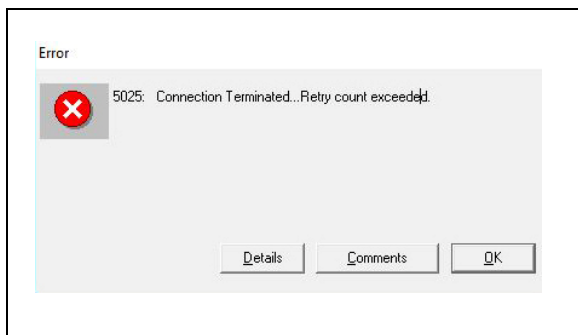
A Windows 10 update affected USB drivers and the RPS USB connection to the control panels listed in the *Products affected* section above.

Attempting to connect to these panels using the B99 USB Direct Connect Cable might produce the RPS error 5025. RPS does not connect.

If RPS is installed on a computer running Windows 10 and cannot connect to a control panel listed above using the B99 USB Direct Connect Cable, use one of the following connection alternatives:

- Network
- IP Direct
- Modem
- Cellular
- Cellular Callback
