# TECHNICAL BULLETIN

# D7039 or DS9431

## **Class A Wiring Issue**

## December 22, 2009

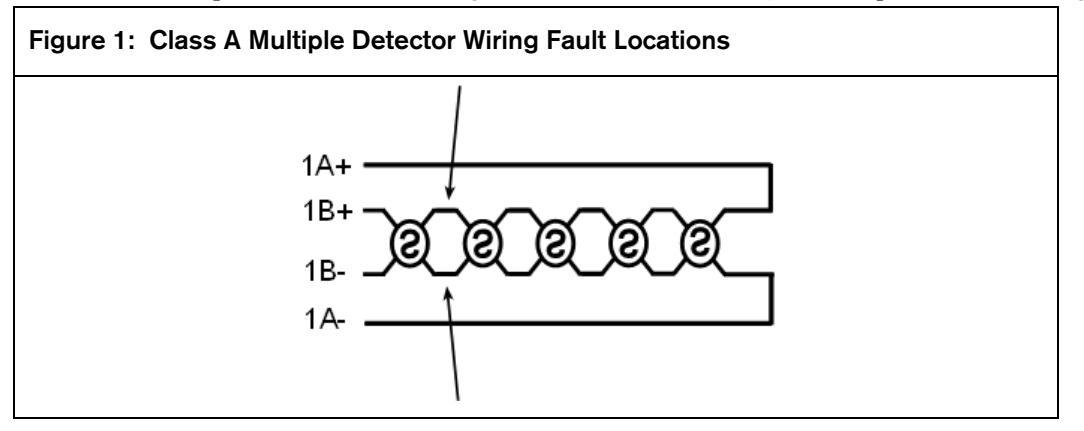
When wired in a Class A configuration, the D7039 or DS9431 MUX Expansion Modules (with v1.04 firmware) might not detect a single wire fault on the B side of the MUX bus when it occurs between the first and second device. For example, if one of the wiring locations indicated in *Figure 1* is open, this issue might occur.

The result is that the Fire Alarm Control Panel (FACP) might not indicate a MUX wiring fault, and might not initiate an alarm from any device.

Use a Class B wiring configuration. If this is not possible, replace the D7039 or DS9431 with a v1.05 or later MUX expansion module. To ensure normal operation, replace all v1.04 MUX expansion modules that are installed in Class A configurations as described in *Section 3.0 Replacing the D7039 or DS9431*. After replacing the MUX expansion module, perform the system test described in *Section 4.0 Class A Broken Wire Certification Test* on page 3.

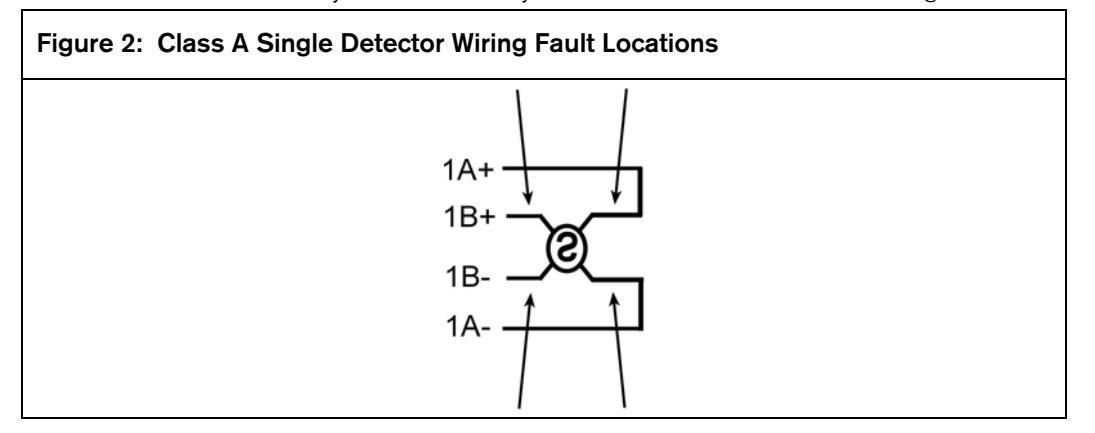
This issue also occurs at any location on a system with one device, at the wiring locations indicated in Figure 2.
