Technogram

02/02

Affects: D7039

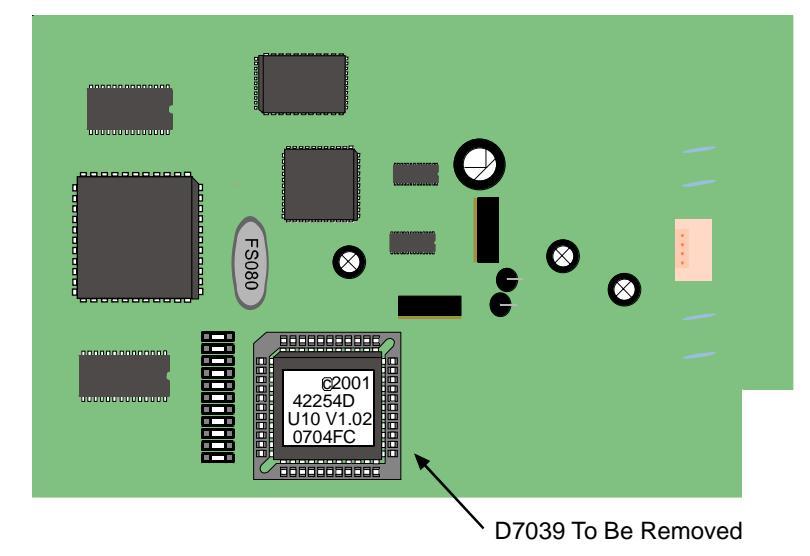
The chip to be replaced is resting in a square socket in the lower central portion of the board. See the diagram below.

Place the tips of the PLCC extraction tool in the slots on diagonal corners of the socket. Then push the handles of the extractor in while gently lifting straight up. Do NOT rock the chip or pull one side up before the other as damage to the socket may occur. Discard the old chip.

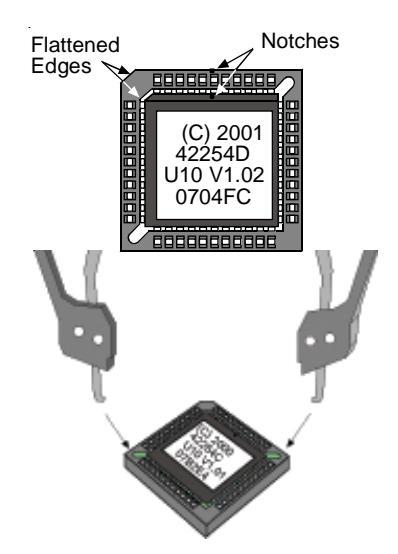
Flattened Edges (C) 2001 42254D U10 V1.02 0704FC

Notice that one corner of the chip and one corner of the socket have been filed flat, and there is a notch in the chip and a corresponding notch in the socket.

When the new chip is inserted into the socket these indicators must line up.

Place the new chip over the socket, ensuring that the notch on the chip is lined up with the notch in the socket and that the flattened corner of the chip is lined up with the flattened corner of the socket. Once this has been determined, slowly push down on the chip making sure that it is fully seated. Again, do not rock the chip or allow one side to go in before the other.
