Technogram

02/02

Affects: D7039

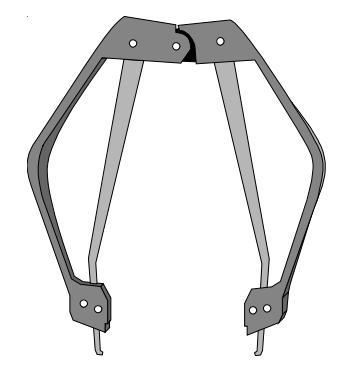
Do NOT use a screwdriver or any other prying device for this procedure. Incorrectly removing or replacing the chip may damage the board. Radionics cannot be responsible for products damaged as a result of incorrectly removing and installing the chips.

You will need a PLCC extraction tool for this procedure. This tool is not supplied with the update kit but may be purchased at Radio Shack (Part Number: 276-2101) or other electronic stores.
