Technical Bulletin
New Generation POPIT reversed wiring

▶ **D9127T**
▶ **D9127U**

August 20, 2024

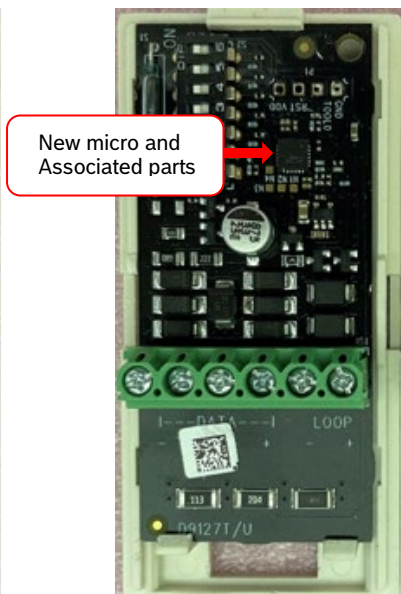
Old POPIT   **New POPIT**

The new generation of POPIT modules will send an "*Open*" status when the bus wiring is reversed. Previous versions of the POPIT module would report "*missing*" if the bus wiring was reversed.

Bosch will update the new POPIT in the near future to provide the same indication of "*missing*" for reversed wiring in order to eliminate any potential confusion.
