## Normally Open (NO) relay not activating for alarm condition

Technical Service Note – October 2, 2013

DS939/DS9370/DS9371/OD850/OD851/  
DS938/DS9360

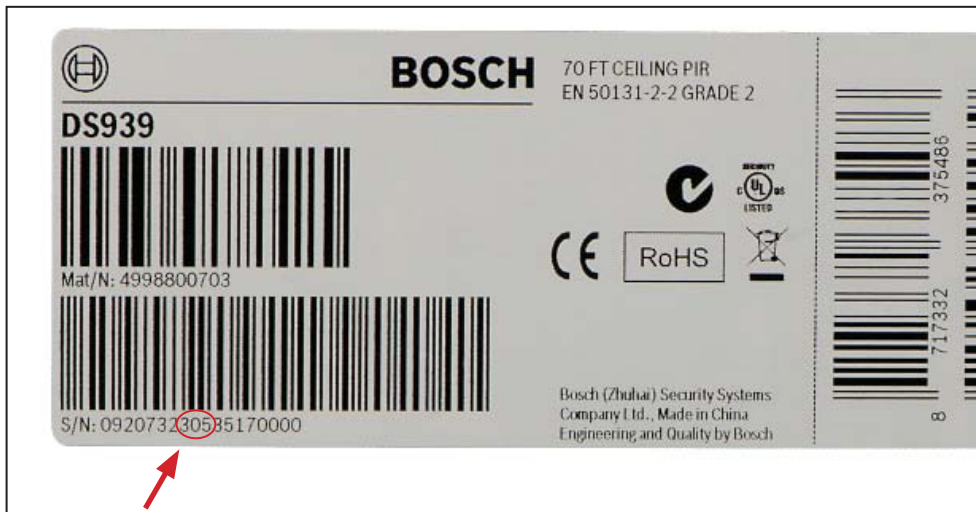
Figure 1.1: Location of date code on box label

To locate the date code on your product or product packaging, refer to Figure 1.1 and Figure 1.2 below. The manufacturing date is encoded in an 18 digit alphanumeric serial number in digits 8 through 10.
