# Technical Bulletin

## FMM-7045 Manual Pull Stations

- ▶ Bosch / FMM-7045 pull stations

**January 19<sup>th</sup>, 2021**

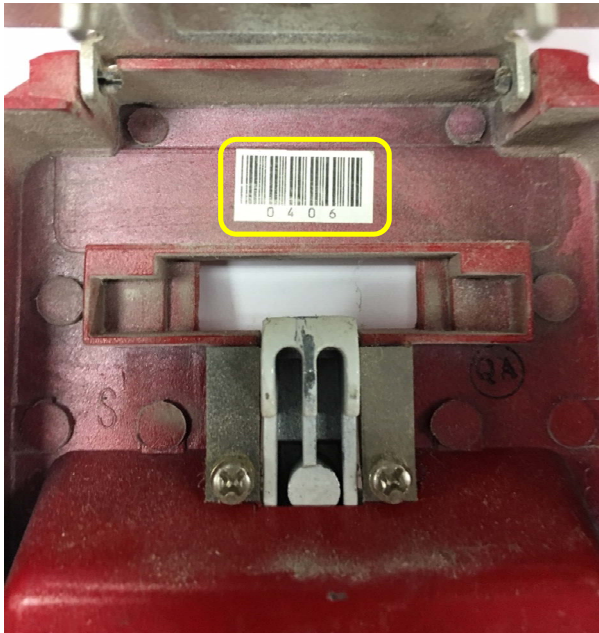
You have received this bulletin because our records indicate that you may have purchased at least one of these products from Bosch during the affected time period. The product model number is located on the label on the inside of the front cover. Products in the affected date range are marked with date codes 06XX on the inside surface of the front cover. For date code locations, see the figures on the back of this sheet.

Location of date code on inside cover of product

Please ensure that you inspect these units during your required NFPA 72 semi-annual visual inspections and annual functional testing.

Pull stations with signs of potential intergranular corrosion should be replaced and returned to Bosch.
